High Temperature Ageing

Condition : +120 °C
Component : QFP100, P0.65mm
PCB Surface : Copper, Pre-flux

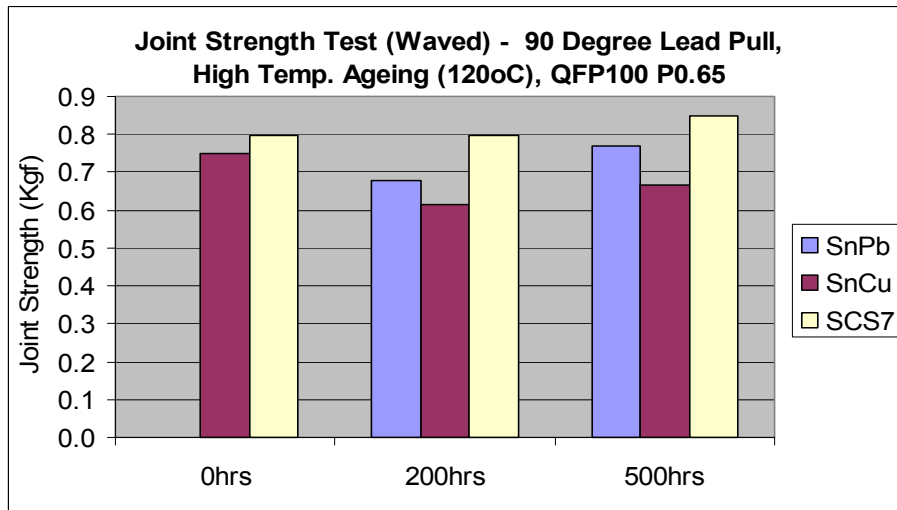
Joint strength of SCS7 remain stable after 500hrs of ageing at high temperature condition.

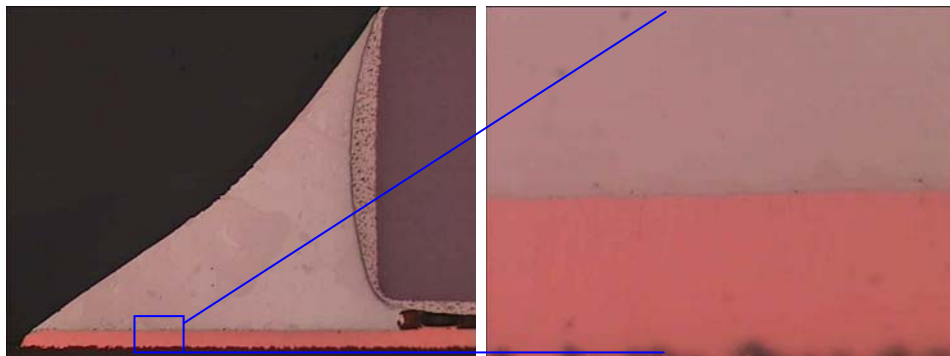
0805 Chip Capacitor

After 1000 hrs High Temperature Ageing:

No abnormalities observed.
